SIGAR 16-22 Inspection Report

Department of Defense Reconstruction Projects: Summary of SIGAR Inspection Reports Issued from July 2009 through September 2015

**MARCH
2016**

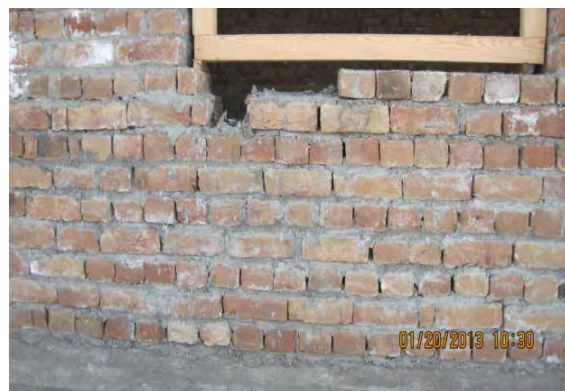
We reported that the Bathkhak School facility, which was under construction in Kabul province at the time of our inspection in 2013, was not being constructed in accordance with contract requirements. For example, instead of a single-story, 10-classroom building, we found two 5-classroom buildings were being built under this USFOR-A-administered project. We also found that the contractor substituted building materials without USFOR-A approval. In one instance, a concrete slab roof was installed instead of a wood-trussed roof, as required by the contract. This raised concerns because the school, which was to be occupied by hundreds of faculty and students, was located in an area of high seismic activity. Further, we found that the school appeared to have construction flaws that could compromise its structural integrity. For example, we found (1) large gaps between bricks in the walls that supported the concrete roof (see example in photo 2);

**Photo 2 - School Building's Exterior Brick Wall
with Gaps in Mortar**

(2) walls that did not appear to be reinforced; and (3) honeycombing, exposed rebar, and concrete form boards remaining in the concrete slab roof.¹⁷ We also found that USFOR-A did not make its first oversight visit to the project site until 6 months after construction began. At that time, the school was 70 percent complete.

Responding to a draft of our inspection report, USFOR-A ordered personnel to have the contractor fix the deficiencies under warranty; however, the unauthorized concrete roof remained an uncorrected problem. USFOR-A's response stated that "a licensed structural engineer from the U.S. Army Corps of Engineers performed a building structural assessment to include test and analysis for determination of the structural integrity of the building. The engineer determined that the ceiling reinforcing may be inadequate and should be monitored for any future cracks." The response also stated that U.S. officials would meet with Afghan authorities to see whether they would accept the risk of the school structure "as is" and, if so, would advise them to monitor the school for cracks.

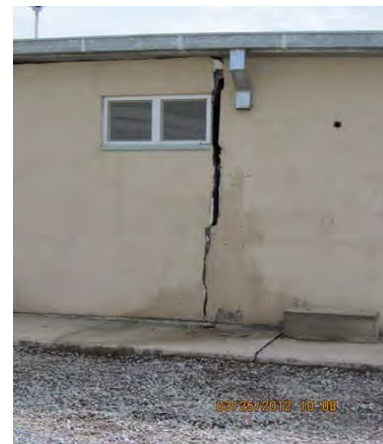
In 2010, we reported that several structures at the ANA garrison in Kunduz were unsafe, uninhabitable, or unusable. The structures were being built under a \$72.8 million contract administered by USACE. We observed severe ground settlement, roadbed cavities, and improper soil grading. We noted that the probable cause of these issues was a lack of adequate soil preparation and pointed out that soil problems were well known in the area. For example, German forces built a camp nearby and used soil replacement, elevated building pads, and drainage systems to counter the risk of collapsible soil. Our report stated, "To protect U.S. investment in the garrison and provide a functioning center for ANA troops currently housed in tents outside the garrison, the issues we observed—most critically, the soil settling and site grading—need to be addressed." However, in a 2012 follow-up inspection, we found that soil instability and structural failure of facilities continued to occur, with ANA soldiers now living on the compound. For example, we found a latrine building that had settled and cracked, and was unusable

Photo 4 - Cracked Exterior of Latrine Building at ANA Garrison in Kunduz

(see photo 4). USACE officials attributed it to water infiltration underneath the building. An adjacent barracks was beginning to settle and was at risk of structural failure. We also found a sinkhole and pooled storm water putting the concrete pad for a transformer that provided much of the base's power at risk of structural failure.

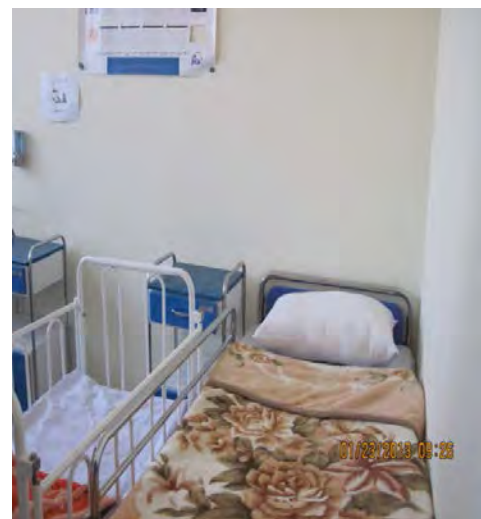
We did not observe any major deficiencies, and our inspection found that the clinic had working heat, electrical, and water systems; floors were clean; medical staffing was good; bedding was plentiful and well kept; and the separate pharmacy building was well stocked. Photo 5 shows a postnatal room. Our report also noted that the Ministry of Public Health had signed an agreement as part of the approval process to sustain the clinic upon completion and that it had fulfilled its commitment to do so, and should be commended for it.

Photo 5 - Postnatal Room at Qala-i-Muslim Medical Clinic
